Thermacote Trials On A GP3 – October 2003

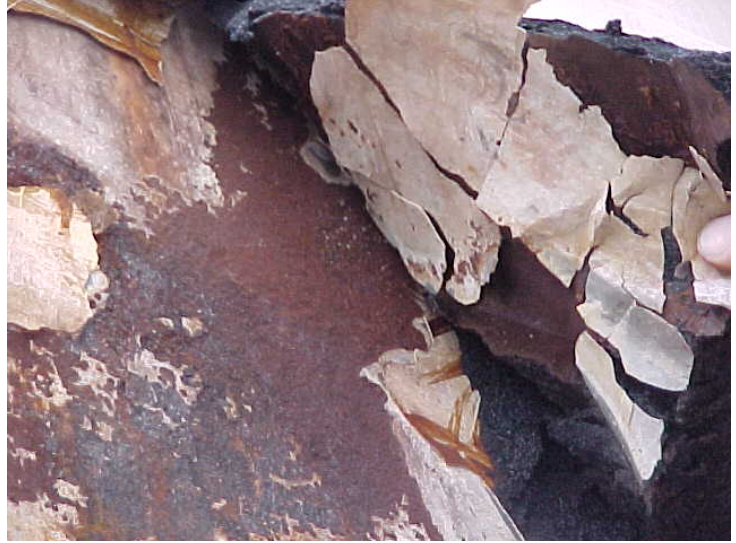
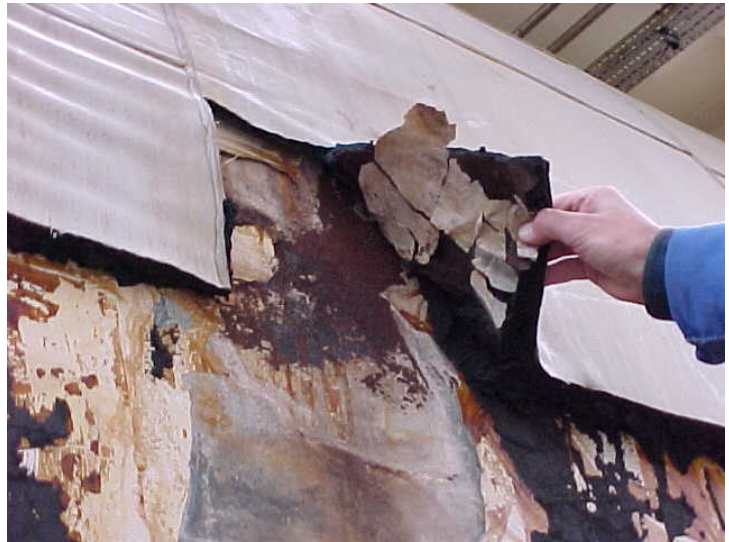
STAGE 1.

- Nitrile rubber stripped away to expose corroded surface.

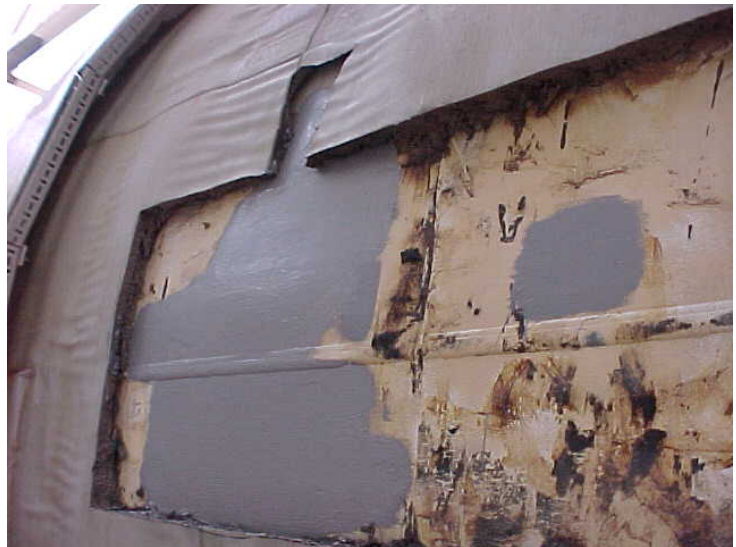
STAGE 2.

- Hot surface prepared with UHP water jetting and primed with Chemco Epochem™ RL500PF (primer / finish)

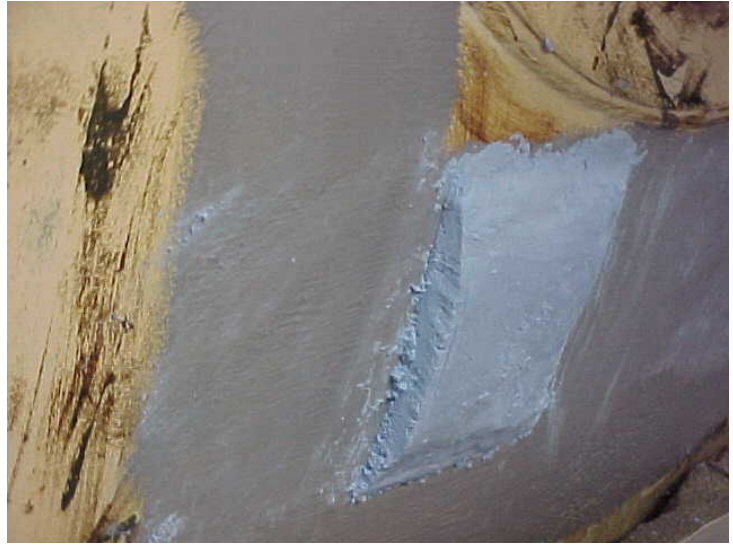
STAGE 3.

- Trial application made of Chemco Thermacote™ solvent free epoxy thermal insulation.
- Application made to hot surface at approximately 10-15mm thickness in a single application.

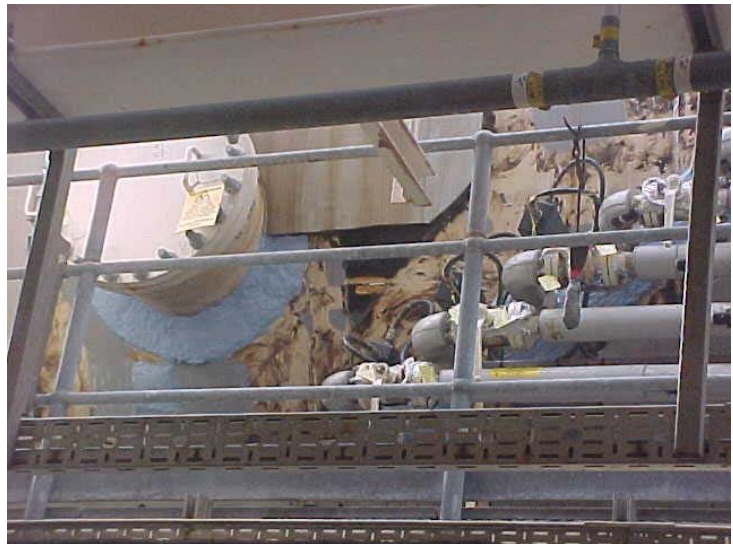
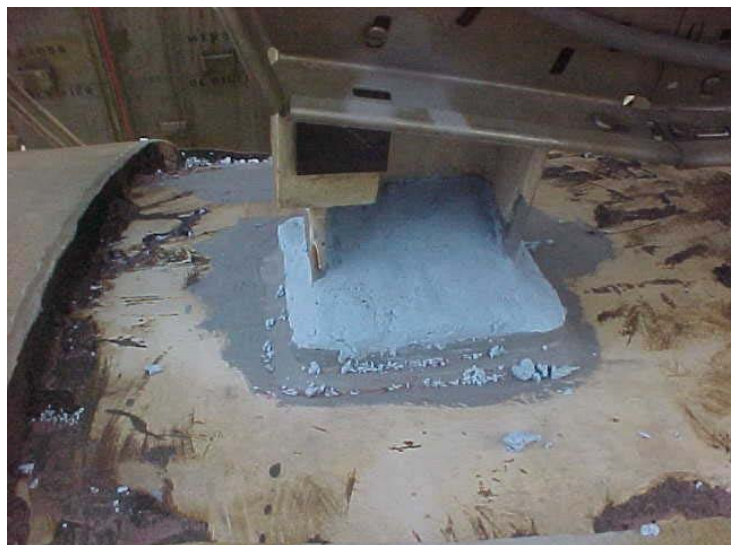
STAGE 4.

- Trial application reduced temperature to <math><40^{\circ}\text{C}</math> in <math><5</math> minutes.
- Trial proceeded to application of Chemco Thermacote™ in pre-designated areas prior to re-application of the nitrile rubber.
- Extremely Easy to mould and stick to flanges and awkward shapes.
- Created good seals to areas always prone to seepage and water ingress

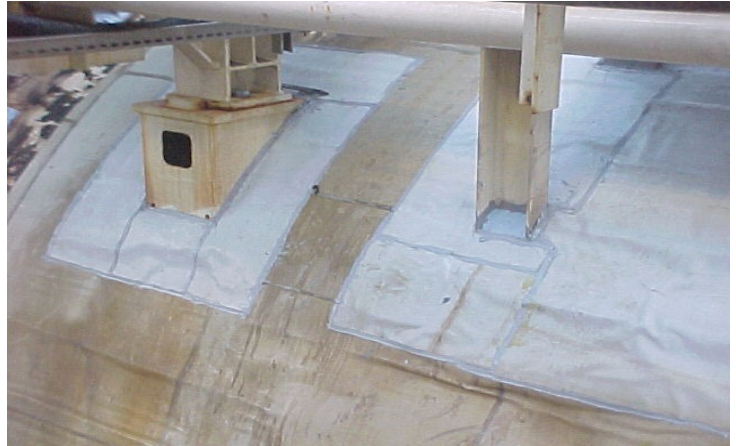
Completed Job

Outer Membrane Re-applied
