<b>Client:</b> <i>London Hospital</i>	<b>Industry:</b> <i>Industrial</i>
<b>Scope:</b> <i>Potable Water Tank Repair</i>	<b>Date:</b> <i>April 2011</i>
<b>Location:</b> <i>UK</i>	<b>Product:</b> <i>Epo-chem™ RS 500P &amp; RA 500M</i>

The hospital's Braithwaite panel tank was in an extremely poor condition as the existing bitumen coating had completely failed.

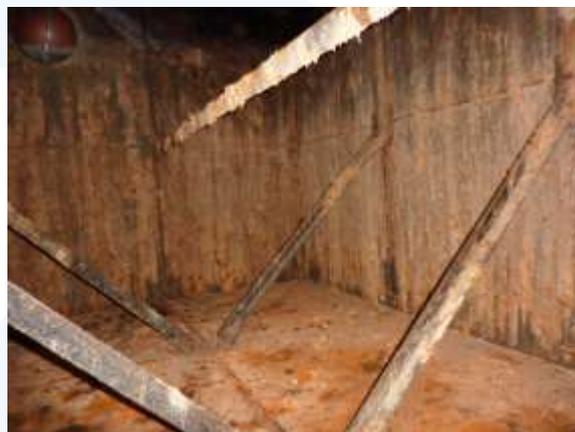
- Nos. 1 and 2 Before application

Manual preparation was selected as the surface preparation method. One primer coat of **solvent-free, wet & rust tolerant Epo-chem™ RS 500P** was applied first. This was followed by two topcoats of **solvent-free, wet tolerant Epo-chem™ RA 500M**.

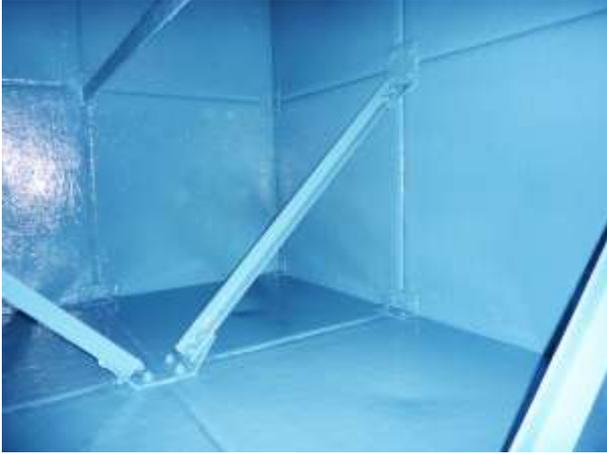
The work was completed within 5 days with the tanks being restored to "as good as new" condition. The unique Chemco system allowed the work to be carried out without disruption to others working nearby.

- Nos. 3 and 4 Completed application
