Client: <i>Facilities Contractor</i>	Industry: <i>Industrial</i>
Scope: <i>Hot Water Tank Lining</i>	Date: <i>December 2019</i>
Location: <i>UK</i>	Product: <i>RE 500P & RW 500</i>

Overview

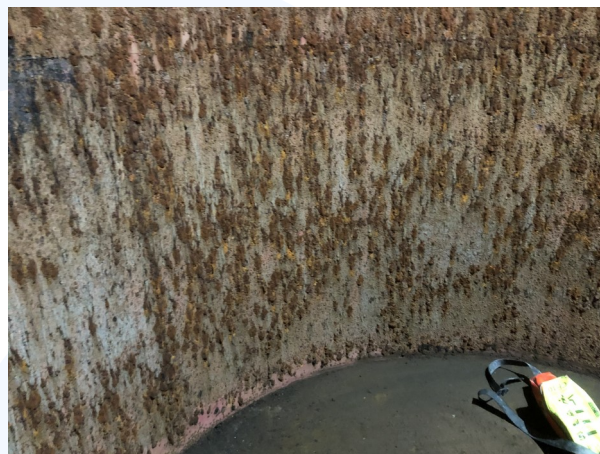
The sealing membrane at the top of the steel hot water tank had burst, allowing oxygen to enter the vessel, leading to corrosion of the tank's internal structure.

- No. 1 Original Conditions
- No. 2 After Surface Preparation

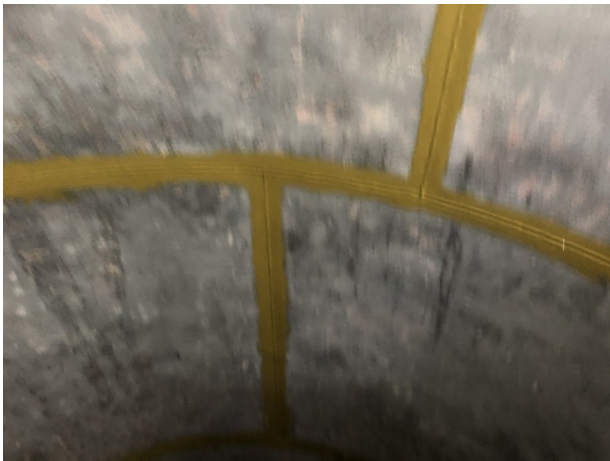
- No. 3 After Stripe Coat of RE 500P
- No. 4 After Application of RE 500P
- No. 5 After Stripe Coat of RW 500
- Nos. 6-7 Completed Application
- No. 8 Tank Externals

One stripe coat and one full coat of **Epo-chem™ RE 500P** was then applied, before one stripe coat and two full coats of **Epo-chem™ RW 500**.
