Client: <i>Large Refinery</i>	Industry: <i>Industrial</i>
Scope: <i>Heat Exchanger Cooler Repair</i>	Date: <i>2020</i>
Location: <i>Belgium</i>	Product: <i>RP 500 and RH 500</i>

A number of water coolers, as part of a larger Heat Exchanger Unit, were showing clear signs of operational damage and required to be refurbished for safe use in the future.

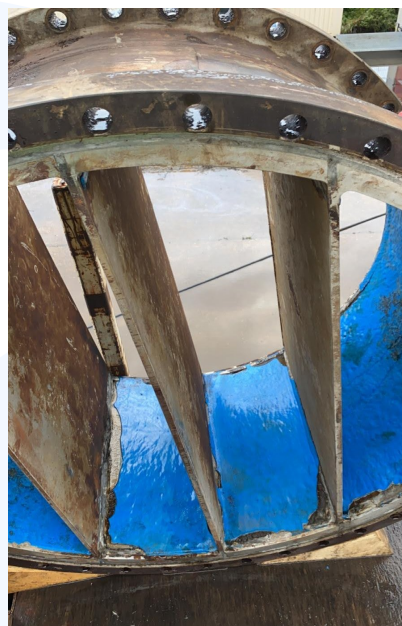
- No. 1 After Initial Cleaning
- No. 2 Completed Application

After all welding and repair works were completed, the water coolers were grit blasted.

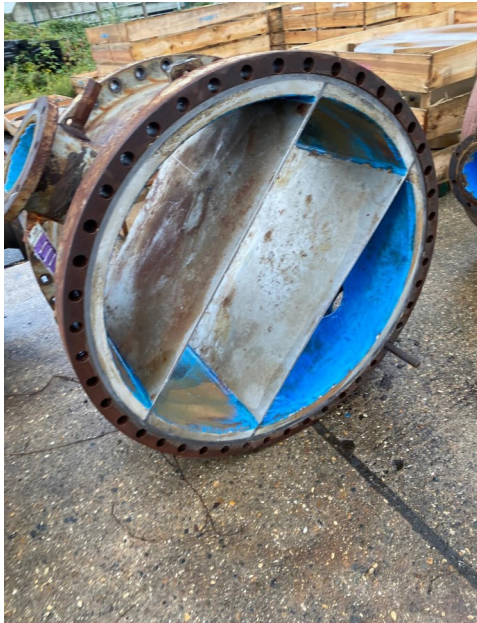
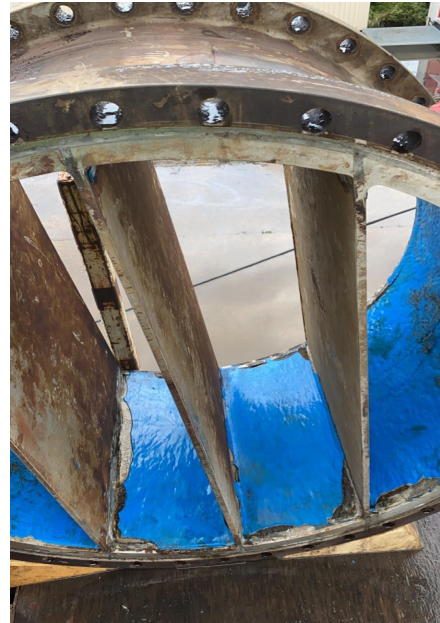
- Nos. 3-4 After Initial Cleaning
- Nos. 4-5 During Application
- Nos. 7-8 Completed Application
