**M45 – Chemical Tank Refurbishment  
– Chemical Tanker (Vinylester)**

Chemical Tank Refurbishment

Poland

2016

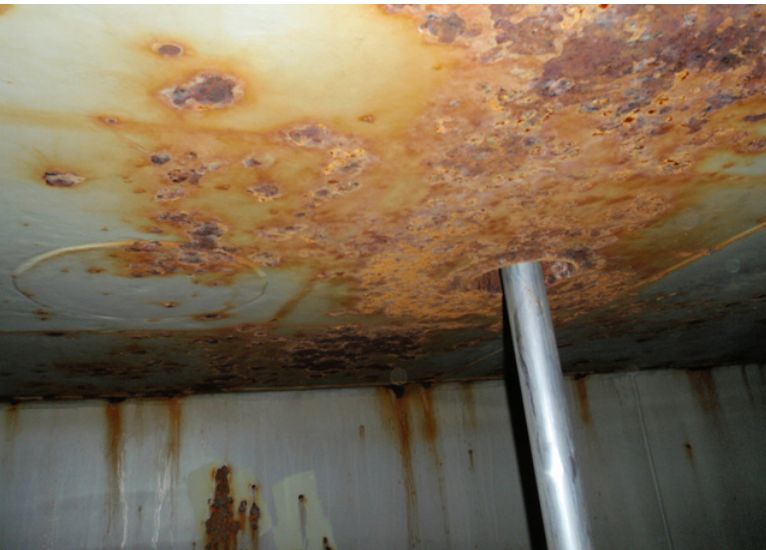
The original coating located in the chemical cargo tanks onboard the chemical tanker had failed.

The tanks were therefore suffering from severe corrosion damage and had to be refurbished.

Original Conditions

The cargo tanks were grit blasted to Sa 2½ standard.

This was followed by one stripe coat and two full coats of RB 300.

To complete the coating system, one topcoat of RB 300TC was applied.

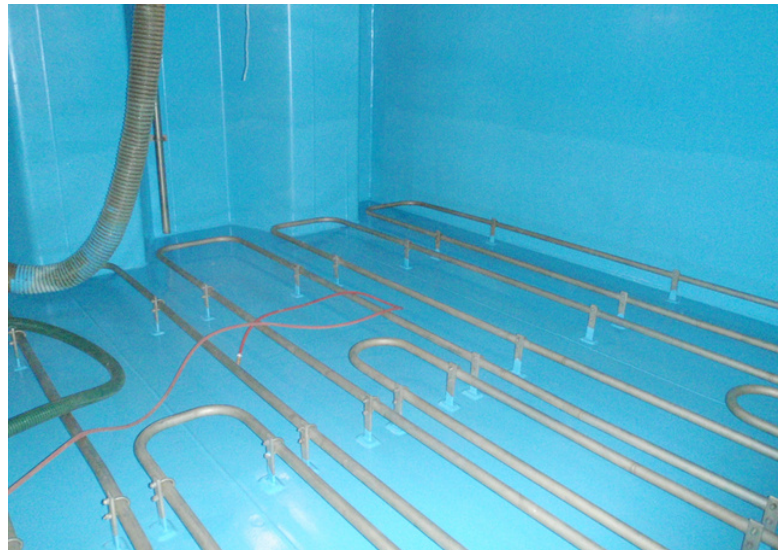
Completed Application

All the chemical cargo tanks were completed to class standard and certified accordingly.

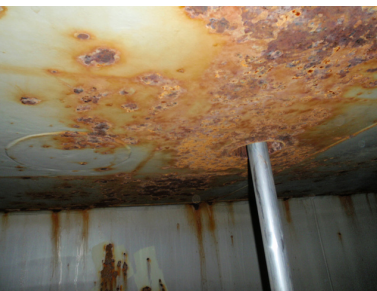
Original Conditions

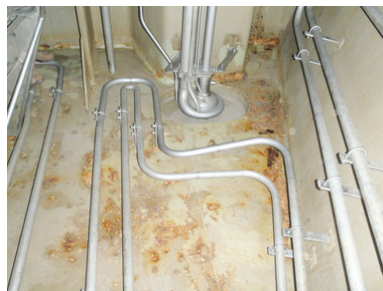
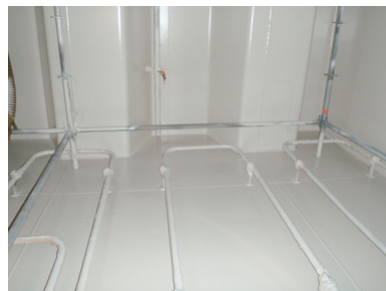
After Applying RB 300

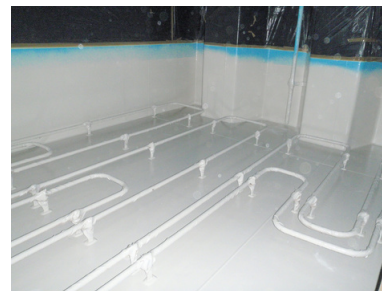
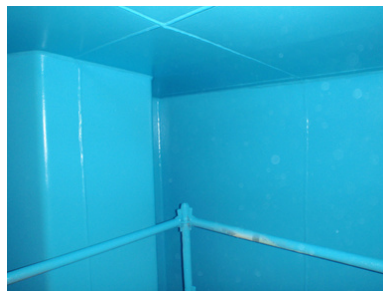
Completed Application
