Client: <i>Major Cruise Line Operator</i>	Industry: <i>Cruise</i>
Vessel: <i>Cruise Ship</i>	Date: <i>October 2017</i>
Location: <i>Germany</i>	Products: <i>Epo-chem™ RS 500P & RA 500M</i>

The swimming pool on-board a large cruise ship was suffering from corrosion and paint breakdown. Refurbishment with a new coating solution was required to ensure the pool was operational and aesthetically pleasing for guests onboard.

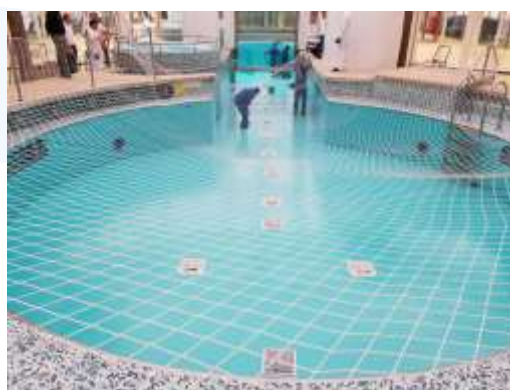
1

- Nos. 1-5 Completed Application

The surfaces were prepared using a combination of mechanical preparation and water jetting, to ST-2 and WJ-3 standards respectively.

One stripe coat and one full coat of solvent-free, wet & rust tolerant epoxy primer **Epo-chem™ RS 500P** were then applied; followed by two coats of solvent-free, wet tolerant **Epo-chem™ RA 500M**.
