Client: <i>Shipmanagement Company</i>	Industry: <i>Marine</i>
Scope: <i>Cargo Tank Patch Repair</i>	Date: <i>February 2020</i>
Location: <i>Denmark</i>	Product: <i>RB 300</i>

10 cargo tanks onboard a large chemical tanker were showing significant signs of corrosion damage. This was due to part failure of the original coating system, and subsequent failure of an unknown coating used for touch-up repairs.

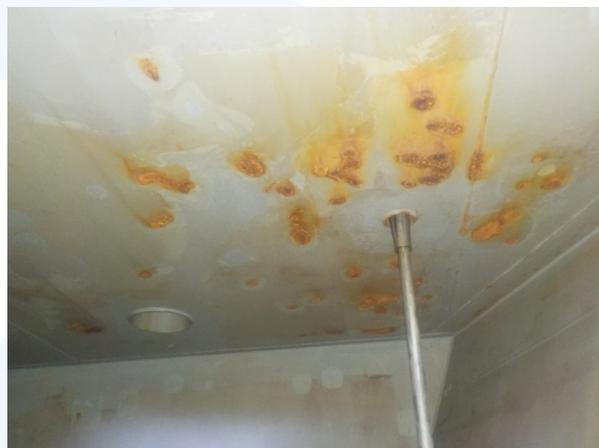
- No. 1 Original Conditions
- No. 2 During Surface Preparation

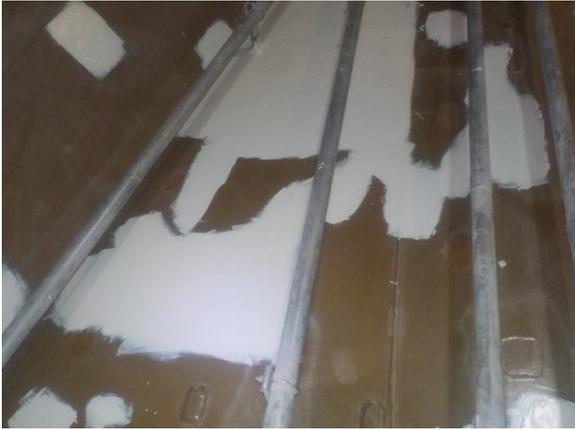
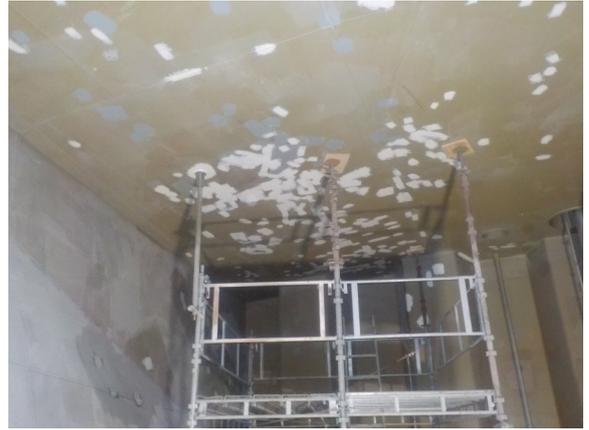
- Nos. 3-4 After Application of RB 364
- Nos. 5-7 After Application of RB 300TC

Two coats of 100% solid, glassflake-reinforced **RB 364** were applied to achieve a WFT of 1000µm.
