<b>Client:</b> <i>Shipmanagement Company</i>	<b>Industry:</b> <i>Marine</i>
<b>Scope:</b> <i>Ballast Tank Refurbishment</i>	<b>Date:</b> <i>Aug-Sept 2020</i>
<b>Location:</b> <i>China</i>	<b>Product:</b> <i>RS 500P</i>

Large areas of the ballast tanks on board a major crude oil tanker were suffering from severe corrosion.

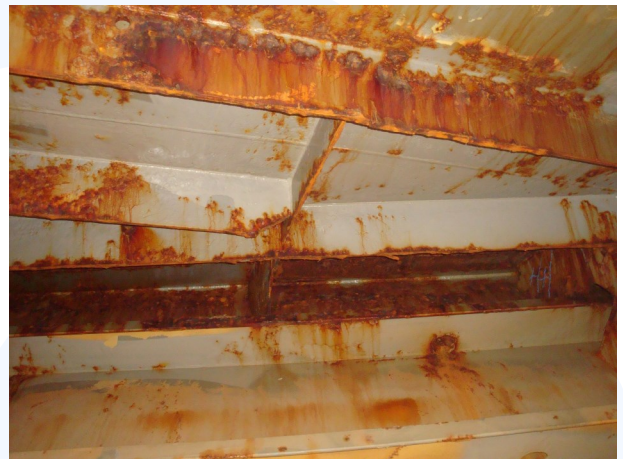
- No. 1 Original Conditions
- No. 2 After Surface Preparation

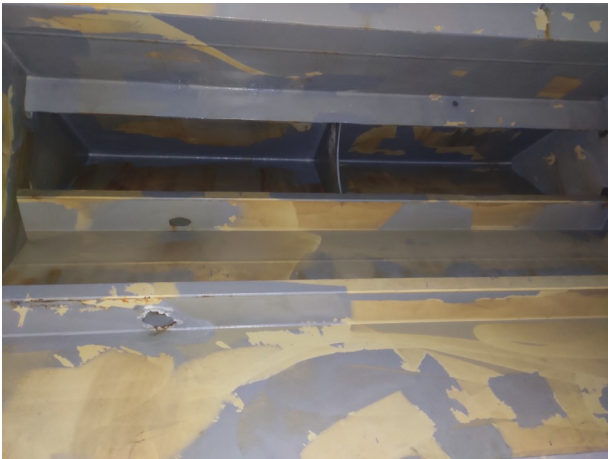
- No. 3 After Stripe Coating
- Nos. 4-5 Completed Application

One stripe coat and one full-coat of Chemco's **solvent-free, wet & rust tolerant coating RS 500P** was then applied to achieve a DFT of 200µm.
