Client: <i>Shipmanagement Company</i>	Industry: <i>Marine</i>
Scope: <i>Ballast Tank Refurbishment</i>	Date: <i>2021</i>
Location: <i>China</i>	Product: <i>RS 500P and RA 500M</i>

The ballast tanks on board a large products oil tanker were suffering from corrosion and required to be refurbished.

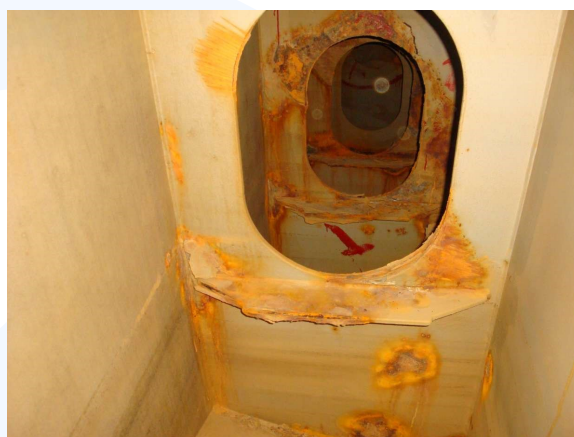
- No. 1 Original Conditions
- No. 2 Completed Application

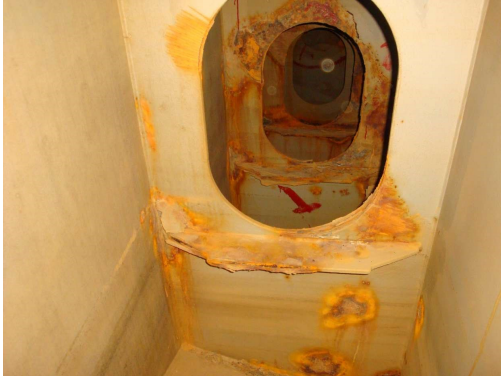
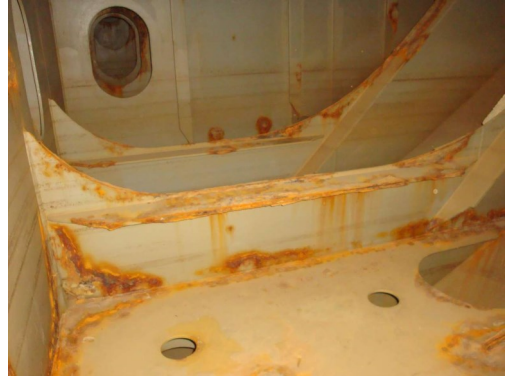
- Photographs:**
- Nos. 3-4 Original Conditions
 - Nos. 5-6 During Surface Preparation
 - Nos. 7-8 During Stripe Coating
 - Nos. 9-10 Completed Application
