Client: ENGIE	Industry: Power Generation
Scope: Water Cooler Repair	Date: May 2019
Location: Belgium	Product: RP 500

During revision works at a power station, a water cooler was dismantled and severe corrosion was observed.

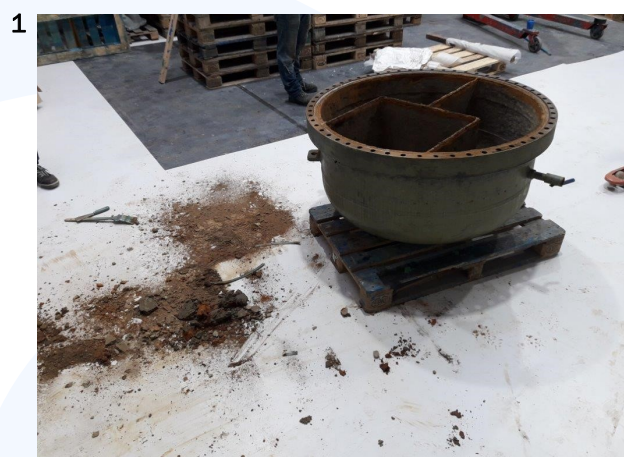
- No. 1 Original Conditions
- No. 2 After Surface Preparation

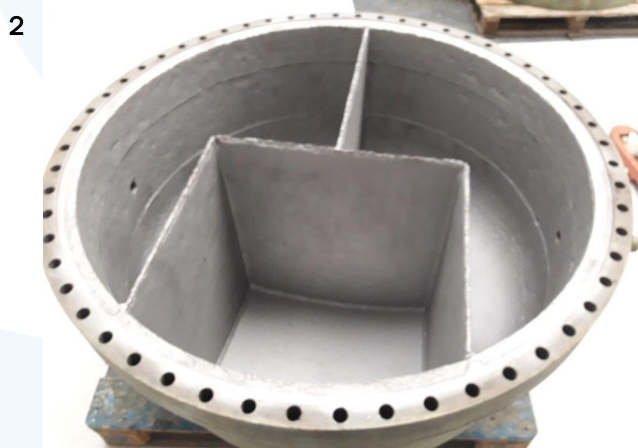
The cooler was cleaned by grit blasting. The welding and machining then took place in order to seal the surfaces areas.

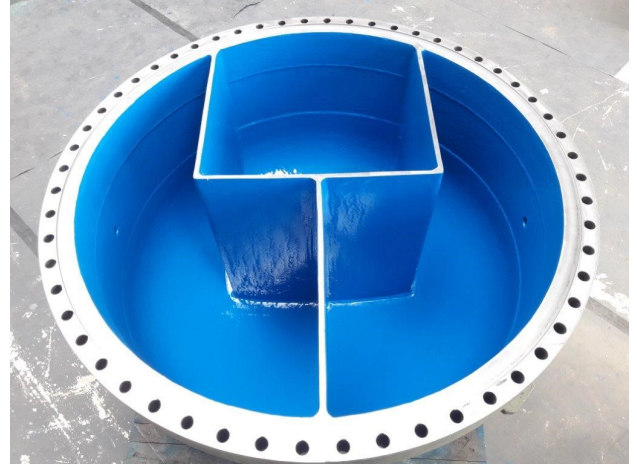
Due to its ability to resist very aggressive fluid flow environments, three coats of **solvent-free** ceramic coating **Ceram-chem™ RP 500** were then applied.

- No. 3 After Surface Preparation
- No. 4 Completed Application
