REPORT

EPO-CHEM™ RA 500 Series

EPOXY SOLVENT-FREE SYSTEM

July 2018

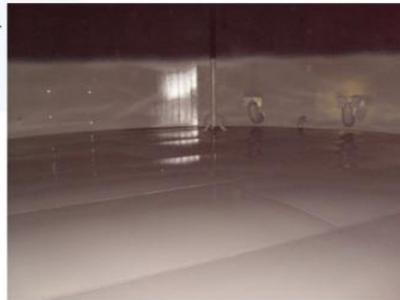
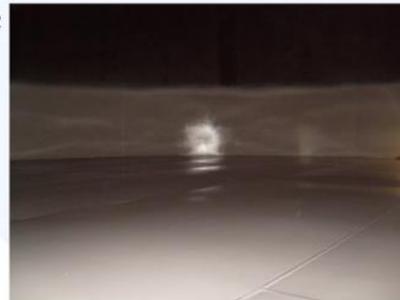
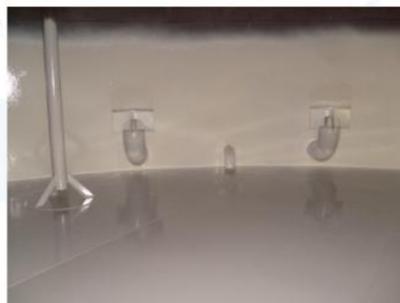
- Nos. 1-3 Application complete

First coat of Epo-chem™ RA 564 solvent-free glass-flake epoxy system @ 500µ DFT by airless spray. All deep pitting were filled with Ceram-chem™ RH 500 solvent-free, ceramic epoxy putty. Second coat of Epo-chem™ RA 564 solvent-free glassflake epoxy system @ 500µ by airless spray.
Total DFT: 1,000µ

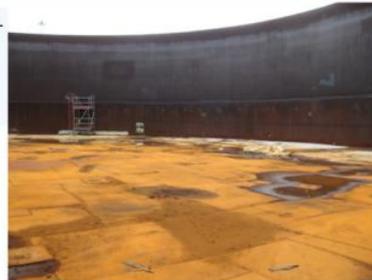
Tank internals suffer from heavy corrosion, pitting and severe metal loss. Combined with the possibility of holes, open-top tank exposed to elements, high humidity, cold and rain adding to the difficulty of this work.

- No. 1 Before application
- Nos. 2-4 Application in Progress

First coat of Epo-chem™ RA 564 solvent-free glassflake epoxy system was applied on grit blasted Sa 2.5 @ 200µ by airless spray. All welded areas and seams were filled using Ceram-chem™ RH 500 high density ceramic epoxy filler. The complete floor area was then fibre-glassed using Epo-chem™ RA 500L (special laminating grade of RA 500 series) and 450gsm of chopped strand mat in 2 overlapping layers. Second coat of Epo-chem™ RA 564 solvent-free glassflake epoxy system @ 400µ was applied by airless spray. Final coat of Epo-chem™ RA 564 solvent-free glassflake epoxy system @ 400µ was applied by airless spray.

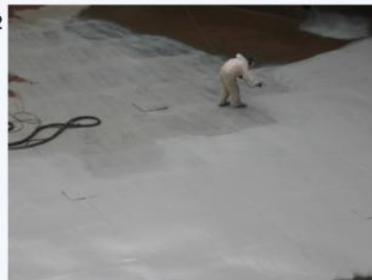
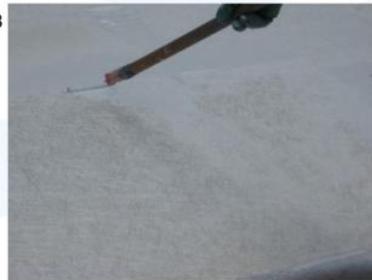
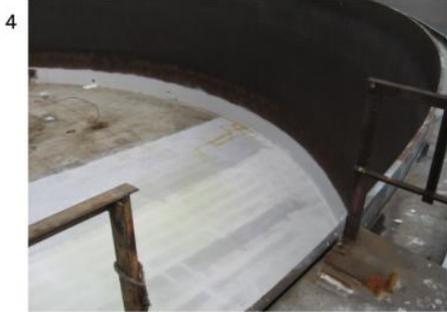
- No. 4 Application in Progress
- Nos. 5-6 Completed Application

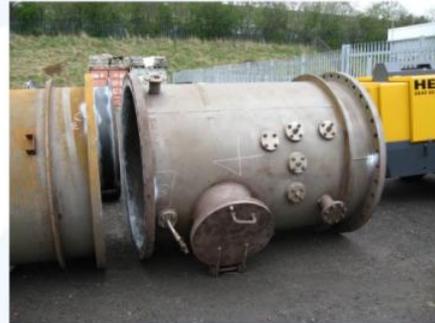
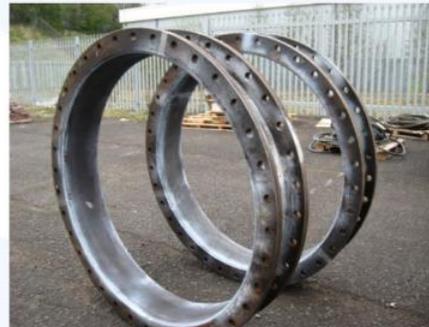
- Nos. 1-2 Pipe Spools Before Application

Two coats of Epo-chem™ RA 564 solvent-free epoxy system @ 500µ per coat by airless spray was applied to both internal and externals of the spools.
 Total DFT Internal: 1,000µ
 Total DFT External: 1,000µ

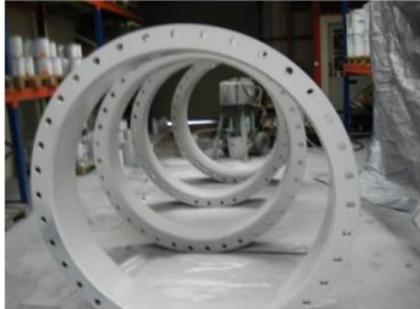
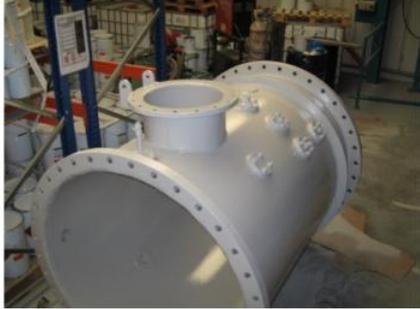
<p>Photographs:</p> <ul style="list-style-type: none">Nos. 3-4 Pipe Spools After Application
--	---

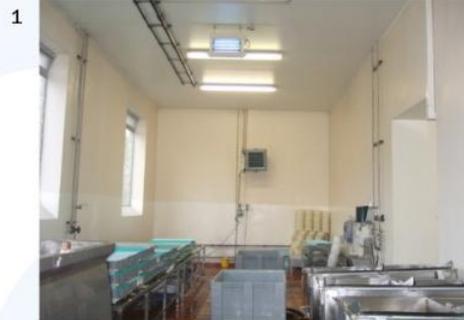
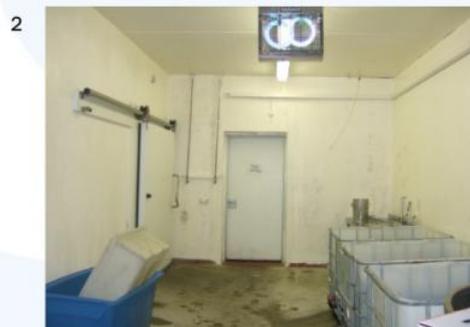
- Nos. 1 & 2 Before Application

Two coats of Chemco Epo-chem™ RA 500M solvent-free, wet tolerant glassflake epoxy system @ 200µ per coat applied by brush and roller.

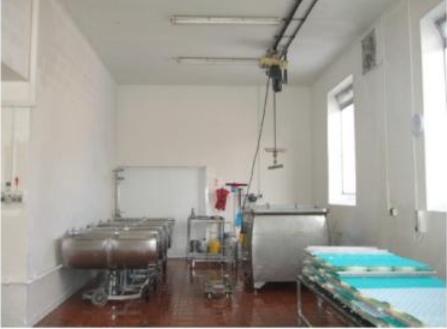
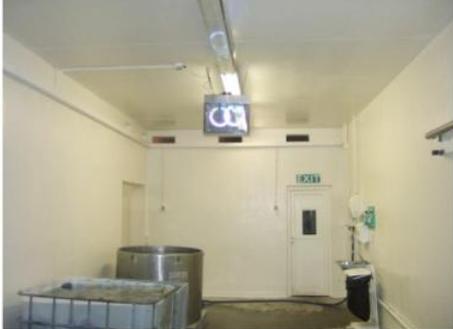
<p><u>Photographs</u></p> <ul style="list-style-type: none">Nos. 3 & 4 After Application

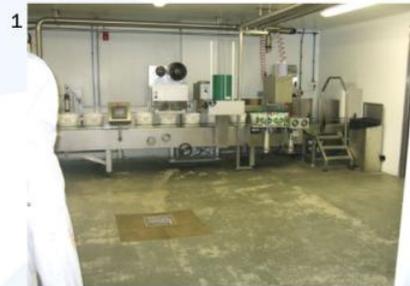
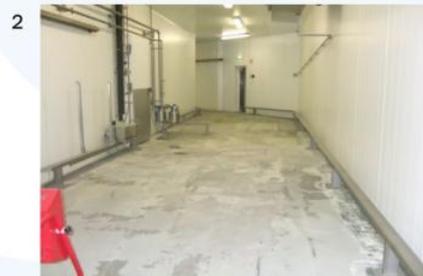
- Nos. 1 & 2 Production Floor Before Application

Two coats of Epo-chem™ RA 500M solvent-free, wet-tolerant epoxy system @ 200µ per coat by roller.

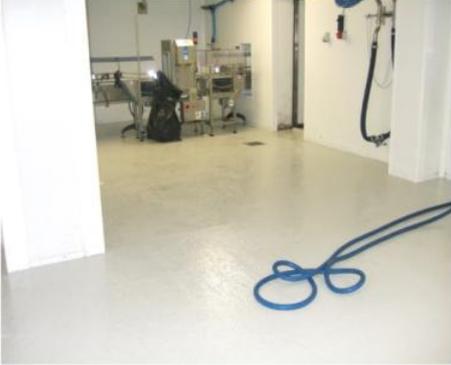
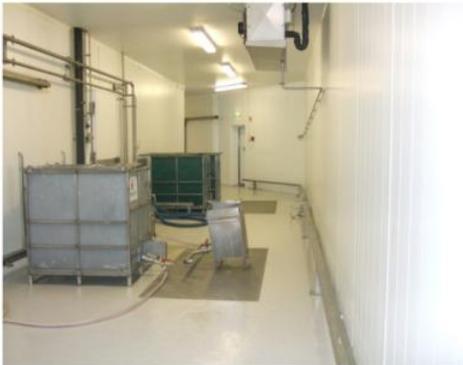
<p><u>Photographs</u></p> <ul style="list-style-type: none">• Nos. 3 & 4 Production Floor After Application

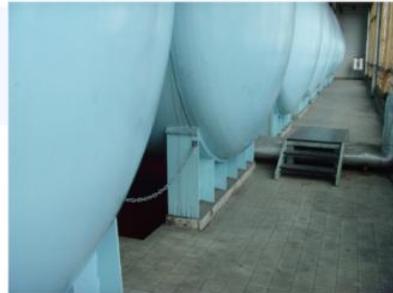
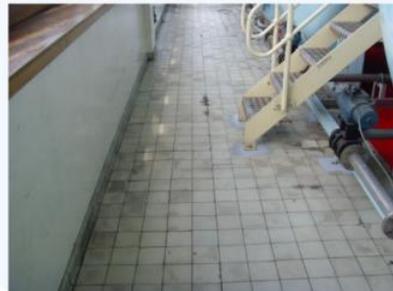
- Nos. 1 & 2 Production Floor Before Application
- No. 3 Production Floor After Application

Easi-prime™ RX 500P, a water-based epoxy with excellent adhesion to ceramic tiles was applied @ 100µ followed by one coat of solvent-free, wet tolerant glassflake topcoat Epo-chem™ RA 564 @ 200µ by brush and roller.

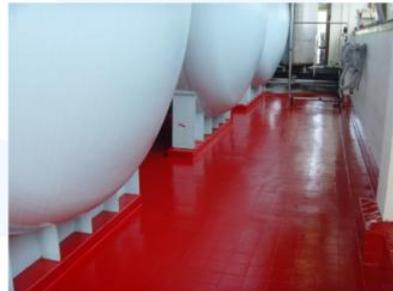
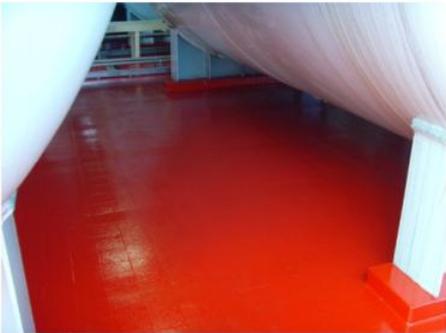
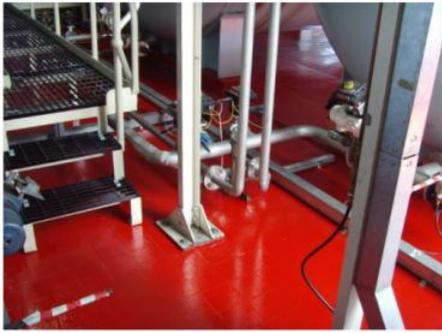
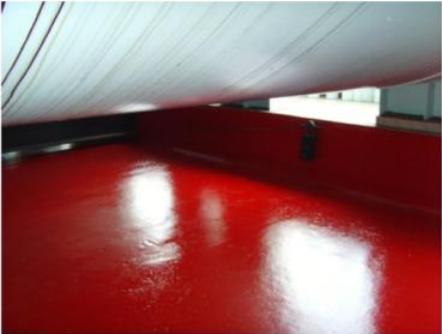
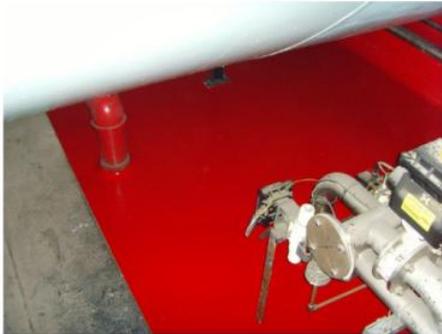
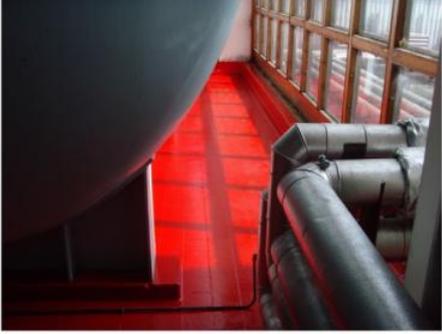
<p><u>Photographs:</u></p> <ul style="list-style-type: none">Nos. 4 - 8 Production Floor After Application

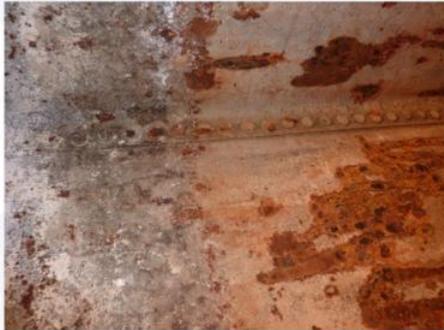
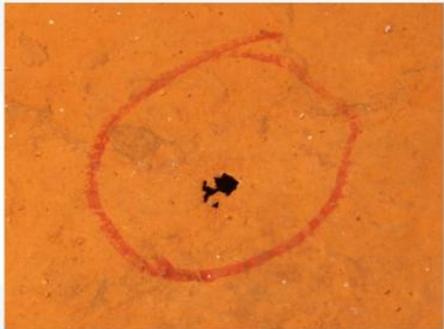
The tanks had holes through their shell, floors and lower walls. The tanks were also located in a confined space on the roof of the building. Working within a strict time frame also added to the difficulty of this project.

- Nos. 1 & 2 Before application

Manual preparation was selected as the surface preparation method. One primer coat of solvent-free, wet & rust tolerant Epo-chem™ RS 500P was applied first. This was followed by two topcoats of solvent-free, wet tolerant Epo-chem™ RA 500M.

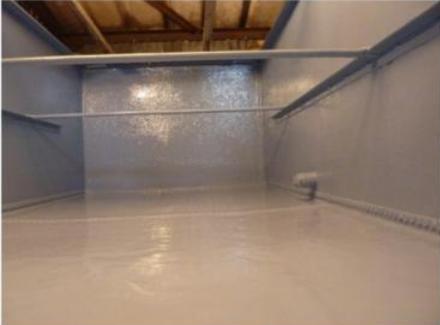
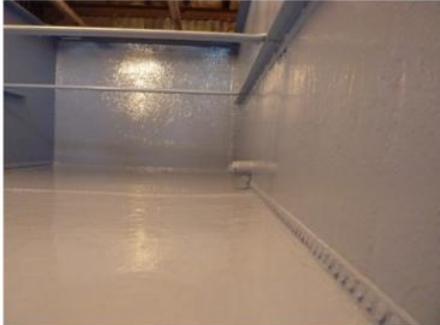
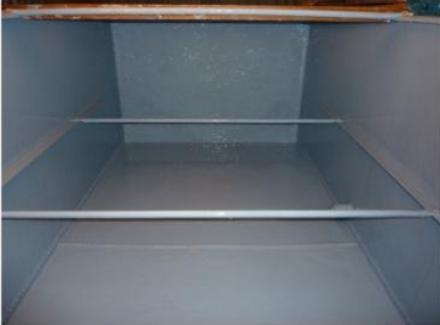
<p>Photographs</p> <ul style="list-style-type: none">• Nos. 3 & 4 After priming• No. 5 Completed application

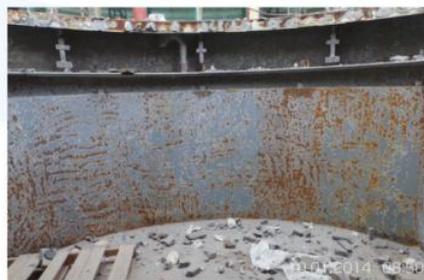
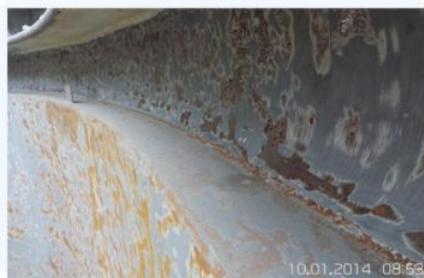
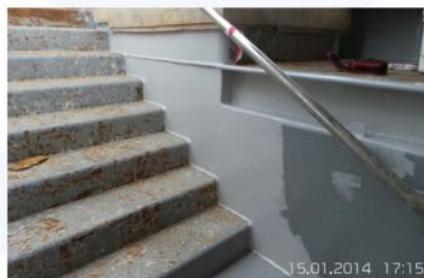
- Nos. 1-2 After Surface Preparation
- No. 3 Topcoat Being Applied on Top of Primer

Both mechanical preparation and water jetting were utilised as the surface preparation methods to St2 and WJ-3 standards respectively. Chemco's solvent-free, wet & rust tolerant primer Epo-chem™ RS 500P was applied followed by two coats of solvent-free, wet tolerant Epo-chem™ RA 500M.

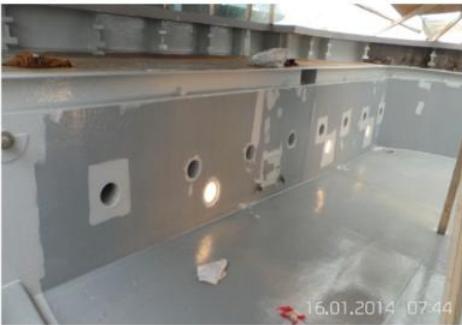
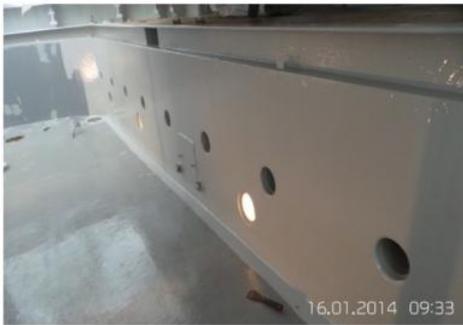
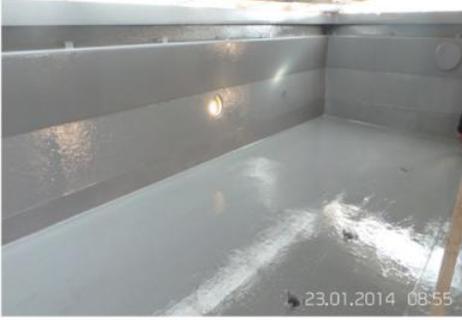
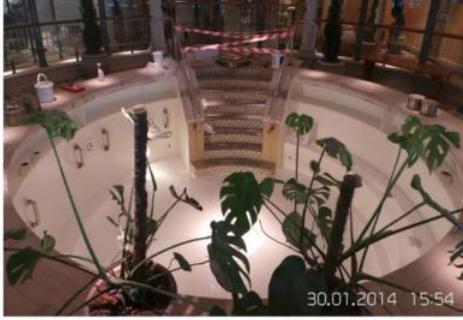
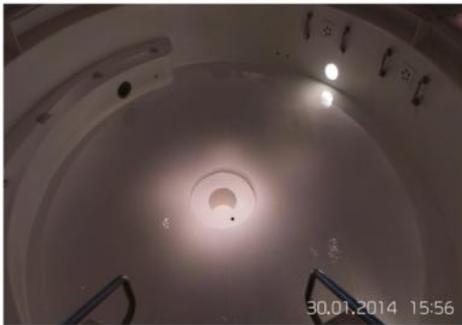
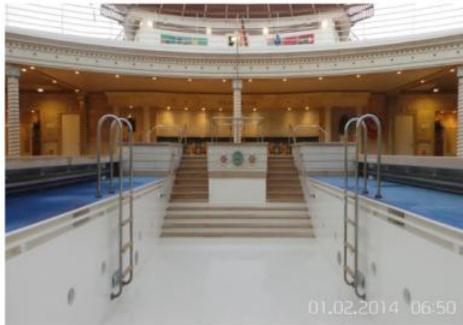
- Nos. 4 and 5 First Topcoat Being Applied
- No. 6 First Topcoat Complete
- Nos. 7 - 9 Completed Application

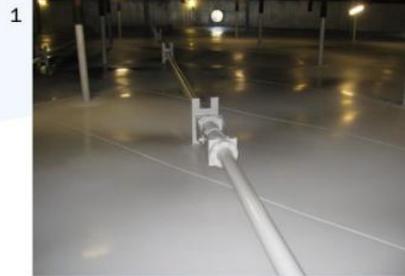
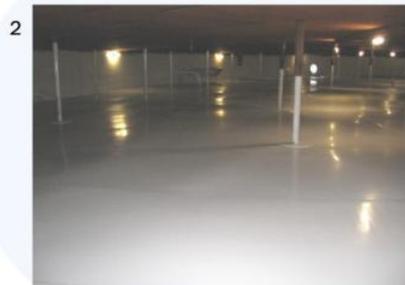
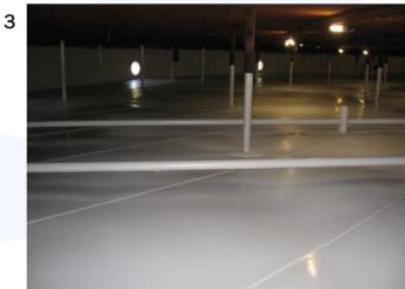
- Nos. 1 - 3 Crude oil tank after application

Two coats of Epo-chem™ RA 564 solvent-free, wet tolerant glassflake epoxy @ 500µ per coat by airless spray with no requirement for ventilation or dehumidification.

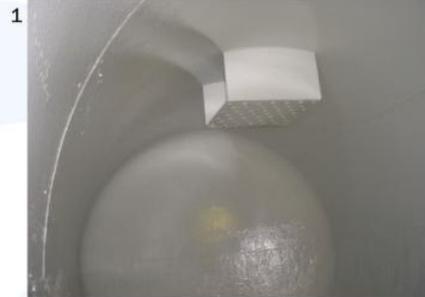
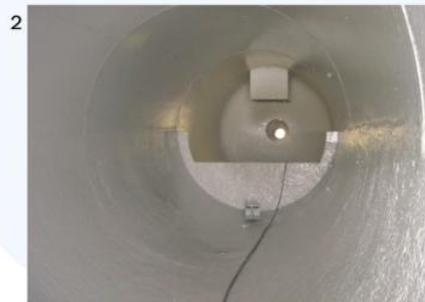
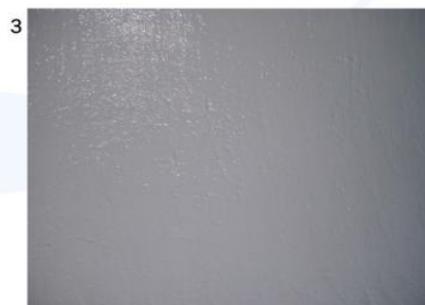
Working within a very tight timescale, severe pitting and corrosion, high humidity, confined space and other contractors working adjacent to the vessel refurbishment added to the difficulty of the project.

- Nos. 1 - 3 The process vessel after application

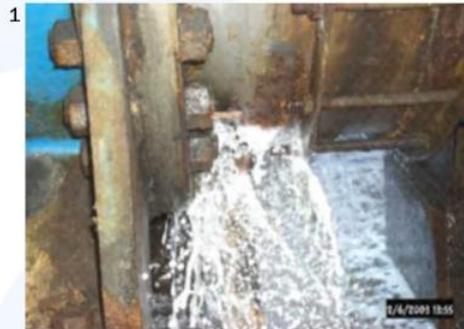
Chemco were requested by the senior mechanical engineer at Alcan Primary Metals to provide a repair system, that would not require a process shut down, to a leaking section of 60" (1,500mm) diameter of their main cooling water pipe work. The pipe work carries seawater which is used for cooling on the main condensers. The problem was perforation, close to both the VJ coupling and the pipe flange adjacent to a butterfly valve. Photograph 1 shows the extent of the leakage and the pressure involved.

- No. 1 The leakage of the pipe
- No. 2 The sealed pipe

The decision was taken to manufacture a split clamping ring, designed to fit between the VJ coupling and the flange. Utilising the amazing ability of Epo-chem™ RA 500 to cure and seal underwater, the area of damage was reduced by the clamp ring being secured, leakage was reduced to a few drops per minute. Further applications of specially reinforced Epo-chem™ RA 500 laminating resin, developed for application in wet conditions, stopped the leak completely. The patch repair was completely successful until the next scheduled shut-down. Photograph 2 shows the successful sealing of the leak.
