# **REPORT**

## **TANK LININGS**

**Traditional & Solvent-free Systems**

**August 2018**

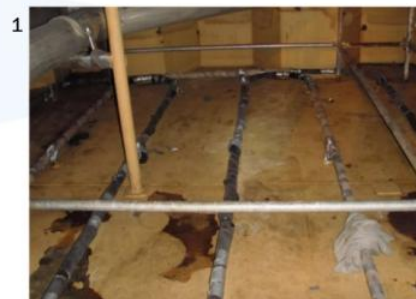
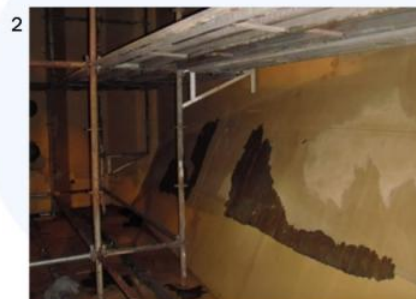
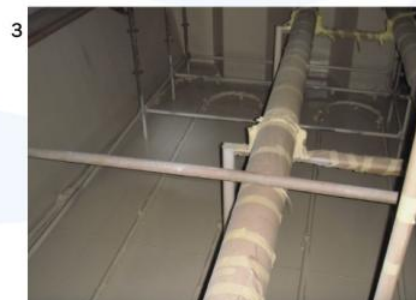
Complete failure of the previous lining as supplied by a major paint company had occurred; the usual phenolic epoxy specified and used would not have the resistance and had to be completely removed and a suitable coating applied; the new lining had to be resistant to most acids and alkaline chemicals at high temperature.

- Nos. 1-2 Original Condition of Cargo Tanks Before Preparation
- No. 3 Tank After First Coat of RB 364

Surface preparation standard: Grit blast to Sa 2½

Coating: Two coats of Chem-tect™ RB 364 @ 500µ DFT per coat plus one stripe coat of Chem-tect™ RB 364.

Total DFT: Minimum 1,000µ

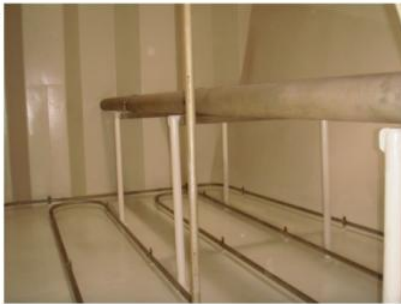
<p>9</p>  
<p><u>Photographs:</u></p> <ul style="list-style-type: none"><li>• No. 4 Tank (port) After Stripe Coating</li><li>• No. 5 Tank (port) After Second Coat of RB 364</li><li>• No. 6 Tank (starboard) After Stripe Coating</li><li>• No. 7 Tank (starboard) After Second Coat of RB 364</li><li>• Nos. 8-9 Tank (starboard) After Second Coat of RB 364</li></ul>

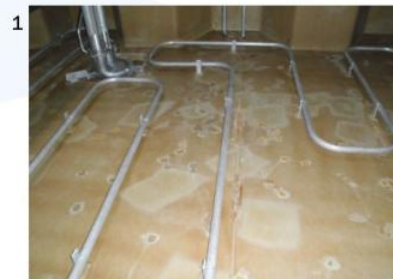
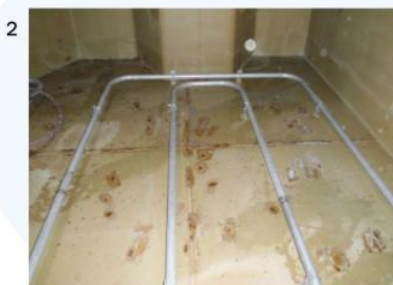
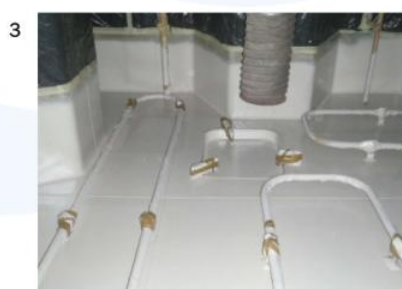
The tank tops found inside four cargo tanks (3 Port, 4 Port, 4 Starboard & 6 Port), onboard the Chemical Tanker, required a full refurbishment as they were showing signs of severe corrosion damage.

- Nos. 1-2 Original Condition
- No. 3 After First Coat of Chem-tect™ RB 364

The tank tops and the bulkheads (up to 0.5m high) were grit blasted to Sa 2.5 standards. Prior to the coating application, the surfaces were swept and vacuumed to remove any dust and other contamination.

- Two coats of Chem-tect™ RB 364 @ 500µ DFT per coat by airless spray.
- One stripe coat of Chem-tect™ RB 364 by brush.
- One topcoat of Chem-tect™ RB 300TC @ 100µ DFT by airless spray.

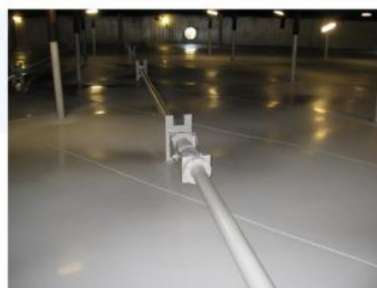
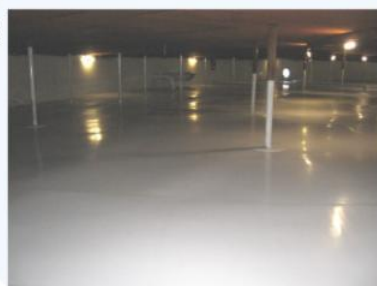
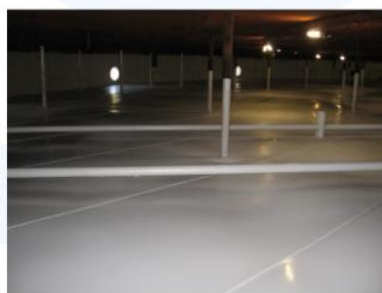
- Nos. 1 - 3 Crude oil tank after application

Two coats of Epo-chem™ RA 564 solvent-free, we tolerant glassflake epoxy @ 500µ per coat by airless spray with no requirement for ventilation or dehumidification.

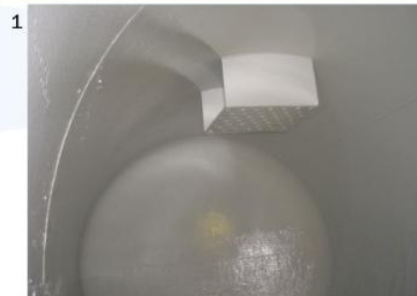
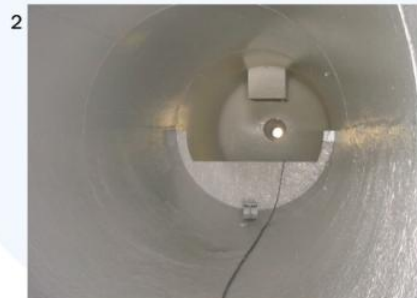
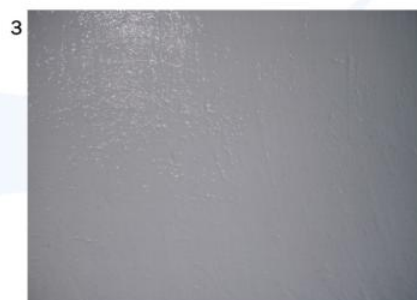
Working within a very tight timescale, severe pitting and corrosion, high humidity, confined space and other contractors working adjacent to the vessel refurbishment added to the difficulty of the project.

- Nos. 1 - 3 The process vessel after application

First coat of **Epo-chem™ RA 564** solvent-free glassflake epoxy system @ 500µ DFT by airless spray. All deep pitting were filled with **Ceram-chem™ RH 500** solvent-free, ceramic epoxy putty. Second coat of **Epo-chem™ RA 564** solvent-free glassflake epoxy system @ 500µ by airless spray. Total DFT: 1,000µ

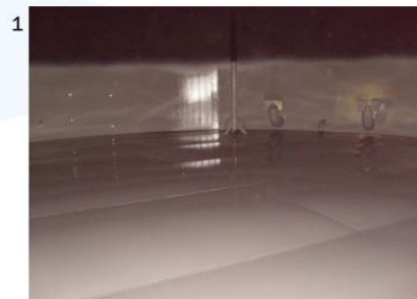
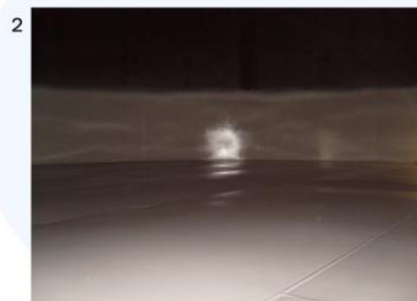
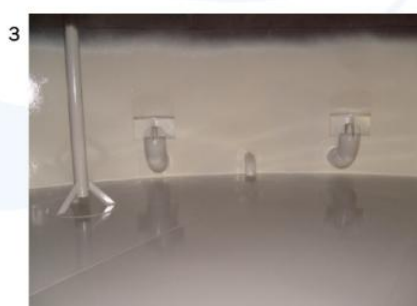
After coming out of a long service, the tank floor was suffering from severe pitting and corrosion. Winter condition, cold weather and high humidity, combined with water ingress, added to the difficulties of this project.

- Nos. 1-3 Application complete

First coat of Epo-chem™ RA 564 solvent-free glass-flake epoxy system @ 500µ DFT by airless spray. All deep pitting were filled with Ceram-chem™ RH 500 solvent-free, ceramic epoxy putty. Second coat of Epo-chem™ RA 564 solvent-free glassflake epoxy system @ 500µ by airless spray.  
Total DFT: 1,000µ

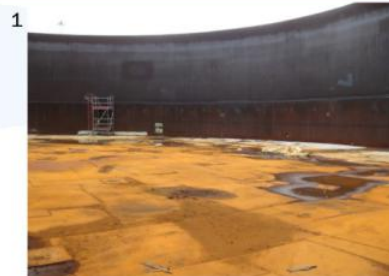
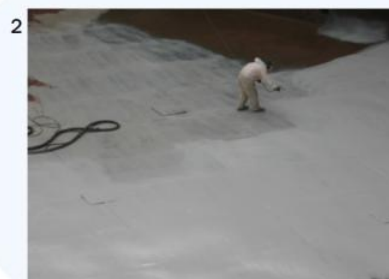
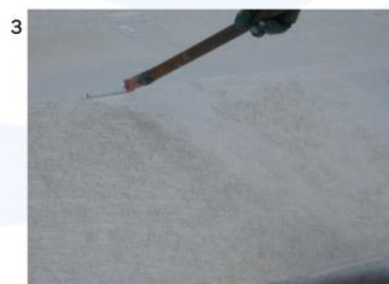
Tank internals suffer from heavy corrosion, pitting and severe metal loss. Combined with the possibility of holes, open-top tank exposed to elements, high humidity, cold and rain adding to the difficulty of this work.

- No. 1 Before application
- Nos. 2-4 Application in Progress

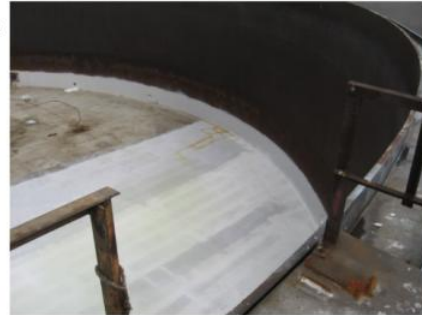
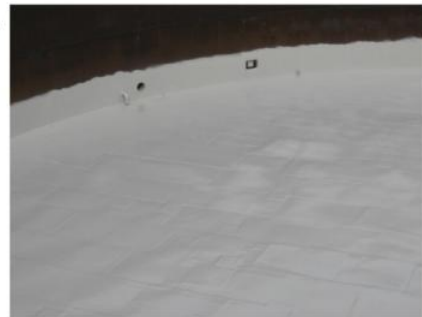
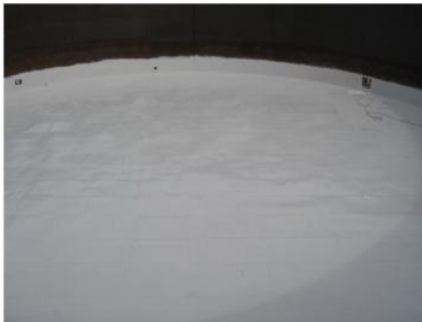
- No. 4 Application in Progress
- Nos. 5-6 Completed Application

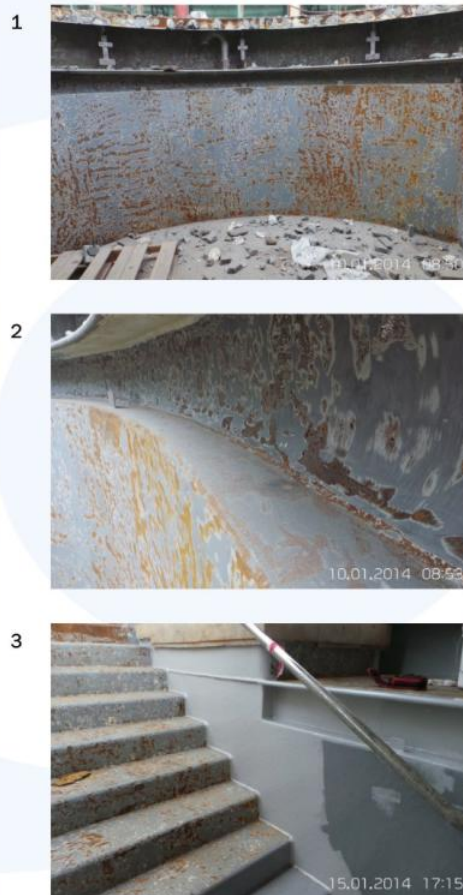
- Nos. 1-2 After Surface Preparation
- No. 3 Topcoat Being Applied on Top of Primer

Both mechanical preparation and water jetting were utilised as the surface preparation methods to St2 and WJ-3 standards respectively. Chemco's solvent-free, wet & rust tolerant primer Epo-chem™ RS 500P was applied followed by two coats of solvent-free, wet tolerant Epo-chem™ RA 500M.

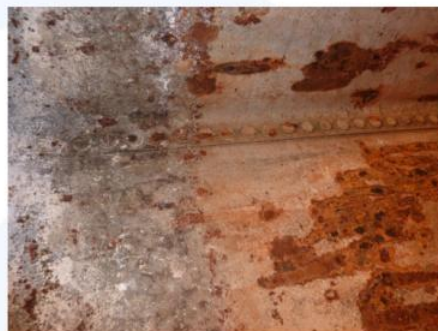
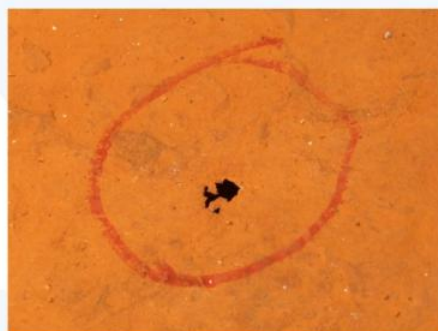
The potable water tanks were approximately 90 years old and were showing signs of corrosion damage. The client required these tanks to be restored to “as good as new” condition.

- Nos. 1 & 2 Before application

Manual preparation was selected as the surface preparation method. One primer coat of solvent-free, wet & rust tolerant Epo-chem™ RS 500P was applied first. This was followed by two topcoats of solvent-free, wet tolerant Epo-chem™ RA 500M.

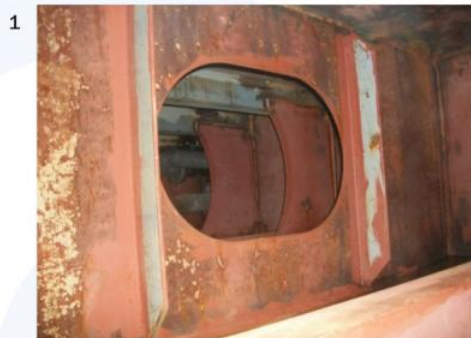
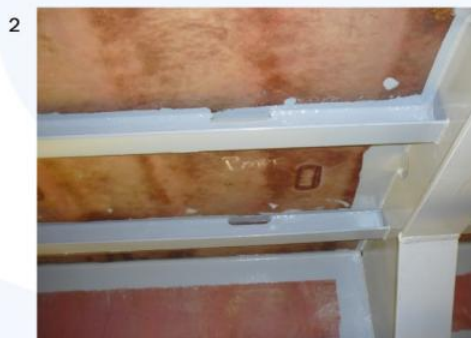
- No. 1 Before application
- No. 2 Stripe coating

Water jetting (500 bar) was utilised as the surface preparation method to remove any contaminants from the shop primed surfaces and the weld areas were mechanically prepared prior to the application of the IMO Approved Chemco System. One stripe coat of solvent-free, wet & rust tolerant Epo-chem™ RS 500P was then applied, followed by one full coat, both @ 100µ. To complete the system, one topcoat of solvent-free, wet tolerant Epo-chem™ RA 500M was applied @ 250µ.

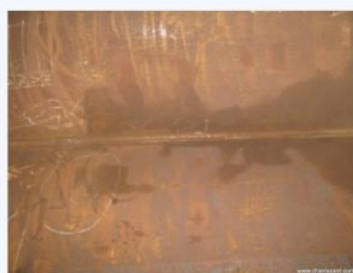
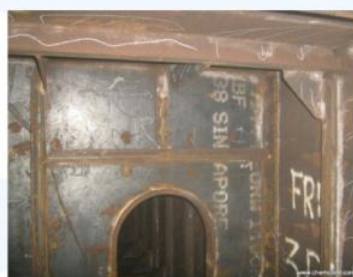
Preparation of the tanks at sea with high pressure washing and coatings to be carried out in high humidity and on rusty steel. Application of solvent-free coatings capable of application on poorly prepared substrate, some without any profile and with mill scale; and still achieve class certification whilst the vessel is in full production/operation.

- No. 1 Talisman on station
- Nos. 2-3 Surfaces ready for coating

High pressure-wash (800 bar) to remove loose rust and loose mill scale. First/Primer coat and stripe coat was carried out with Epo-chem™ RS 500P solvent-free, wet & rust tolerant system @ 100μ DFT followed by the topcoat with Epo-chem™ RA 500M solvent-free, wet tolerant system @ 250μ DFT.

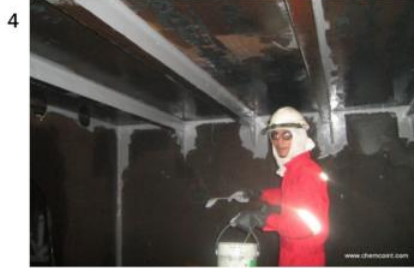
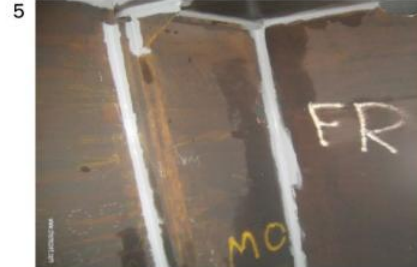
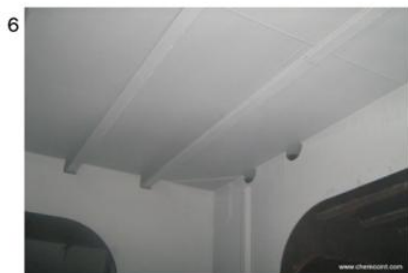
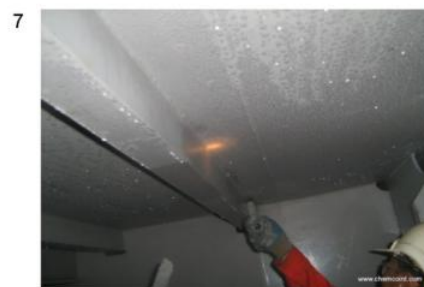
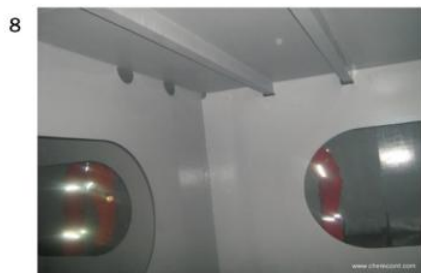
- Nos. 4-5 Stripe coating with RS 500P
- No. 6 Full coat RS 500P
- No. 7 RA 500M being applied on wet surface
- No. 8 Completed RA 500M topcoat

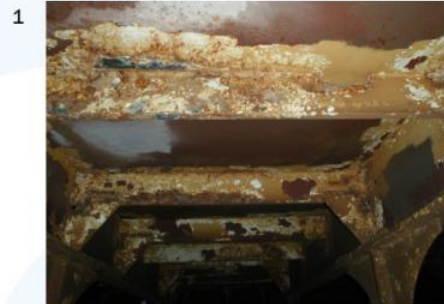
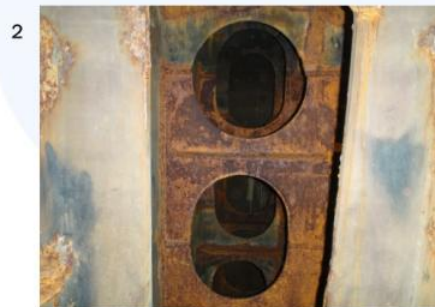
Some areas of the ballast tanks were heavily corroded with limited access. There was also a very limited time-scale for completion of this project and as a result, grit blasting was not permissible.

- No. 1 Deep tank before surface preparation
- No. 2 Wing tank before surface preparation

Utilise water jetting as the surface preparation method to WJ-3 standards. Apply one stripe coat of solvent-free, wet & rust tolerant epoxy Epo-chem™ RS 500P followed by one full coat of Epo-chem™ RS 500P @ 200µ DFT. In some localized areas, where most of the existing paint was still adherent, one primer coat of Epo-chem™ RS 500P in all the bare steel areas was applied, followed by one topcoat of solvent-free, wet tolerant epoxy Epo-chem RA 500M applied @ 250µ DFT.

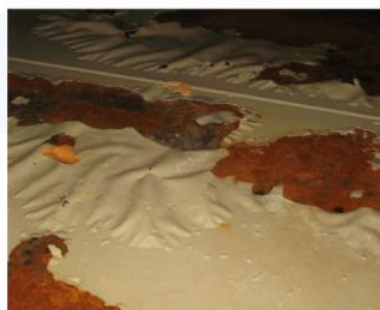
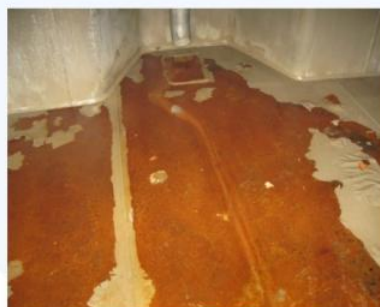
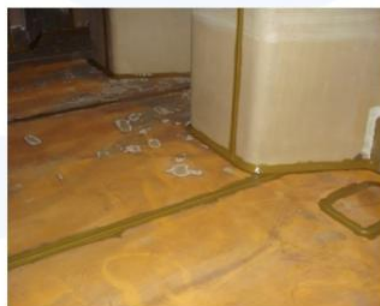
The chemical/oil carrier, built in 2011 and operated by Bernard Schulte Cyprus, had a requirement for a cargo tank refurbishment of 1200m<sup>2</sup> after the original coating (from new) had suffered failure.

- Nos. 1-2 Original Failed Condition of Existing Lining
- No. 3 Stripe Coat of Epo-chem™ RE 500P on the Rusty Surface

To achieve this challenge, water blasting was chosen as the alternative surface preparation method. Chemco's unique Epo-chem™ RE 500P and RW 500 were specified as the preferred coating system. Epo-chem™ RE 500P is a solvent-free, surface (rust tolerant) epoxy Novolac primer and RW 500 is a solvent-free epoxy Novolac glassflake topcoat. The original coating was removed by high pressure water jetting to achieve a WJ-2 standard. The following specification was applied:

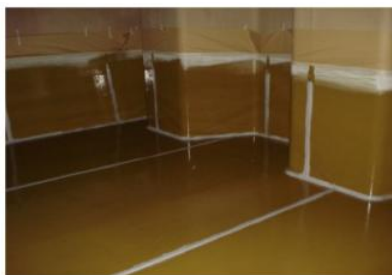
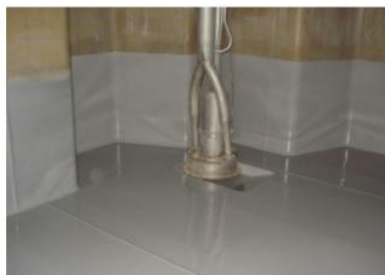
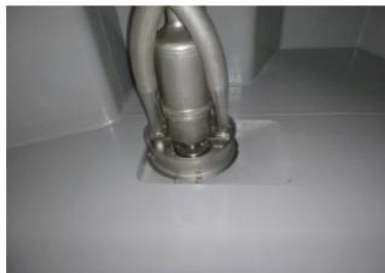
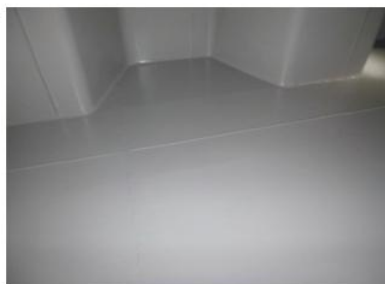
- No. 4 Stripe Coat of Epo-chem™ RW 500 on Primed Surface of Epo-chem™ RE 500P
- No. 5 Contrast Between Finished Application of Epo-chem™ RW 500 and Original Surface
- No. 6 COT 2 Starboard After Carrying Ethanol for 14 days
- No. 7 COT 5 Port After Carrying Ethanol for 14 days

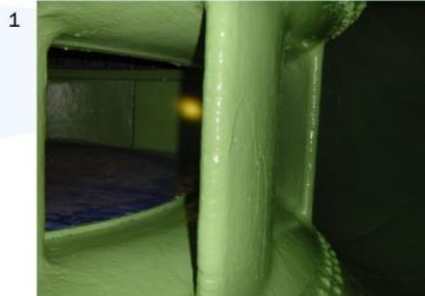
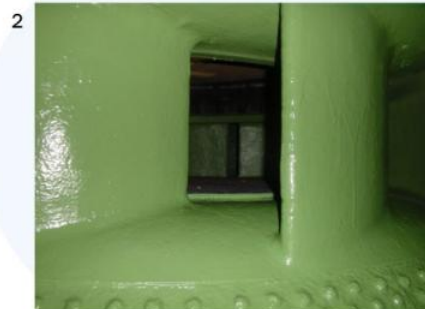
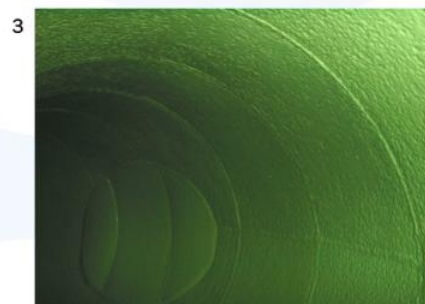
Working within a very tight timescale, severe pitting and corrosion, extremely high humidity, confined space, water ingress and other contractors working adjacent to the spiral refurbishment added to the difficulty of the project.

- Nos. 1-3 Spiral Casing After Application
