<b>Client:</b> <i>Shipmanagement Company</i>	<b>Industry:</b> <i>Marine</i>
<b>Scope:</b> <i>Refrigerant Pipes Refurbishment</i>	<b>Date:</b> <i>2019</i>
<b>Location:</b> <i>Large Reefer Vessels</i>	<b>Product:</b> <i>RS 500P</i>

## Overview

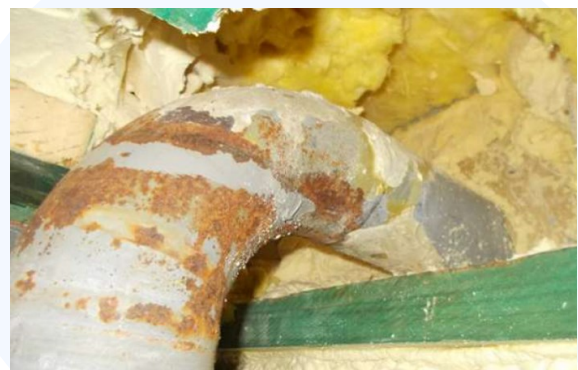
The pipes were contained within thick insulation, making it difficult to identify the leaks. This also made it more difficult to prepare and coat the surface of the pipes.

- No. 1 Original Conditions
- No. 2 Completed Application

The pipe externals were cleaned and mechanically prepared to St 2 standards, before being gradually coated in **RS 500P** and wrapped in fibreglass tape.

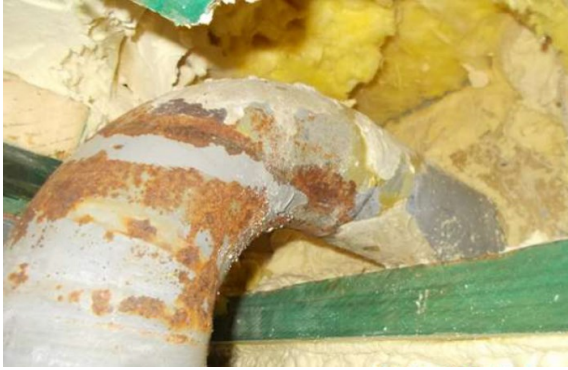
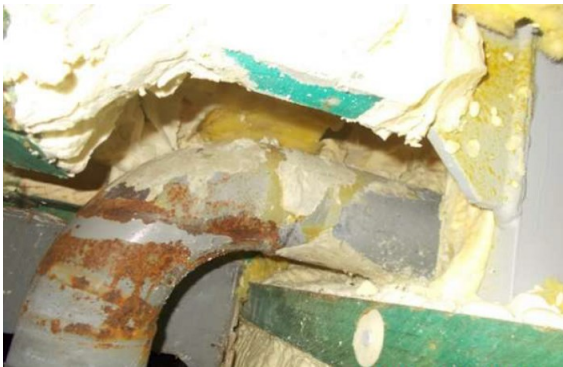
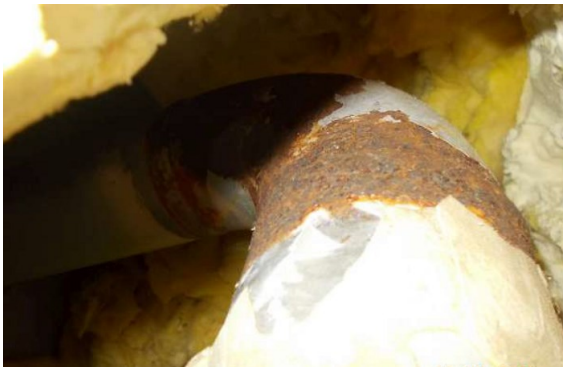
- Nos. 3-5 Original Conditions
- Nos. 6-8 Completed Application
